Special Report 150

CAMP CENTURY REVISITED A PICTORIAL VIEW-JUNE 1969

Austin Kovacs

July 1970

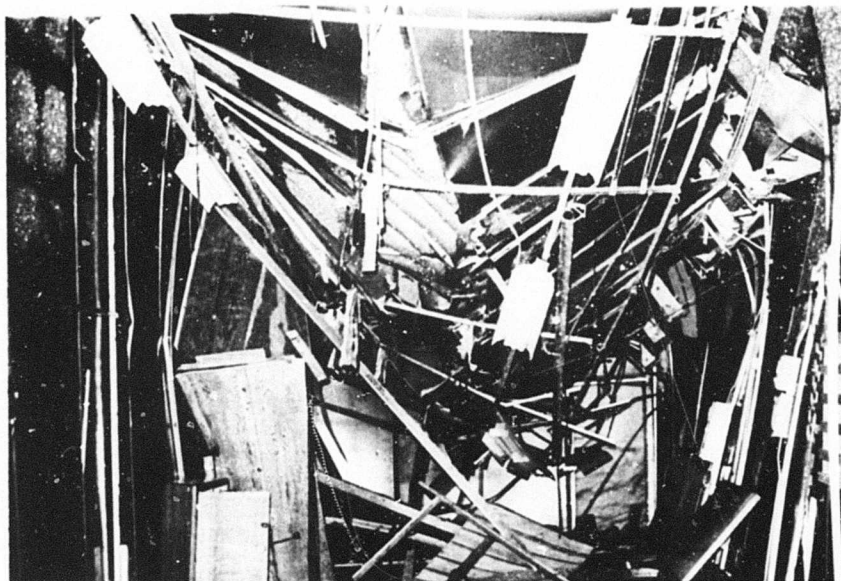
Figure 15. Snow-loaded arch pushes through roof of a reactor building in Trench 3.

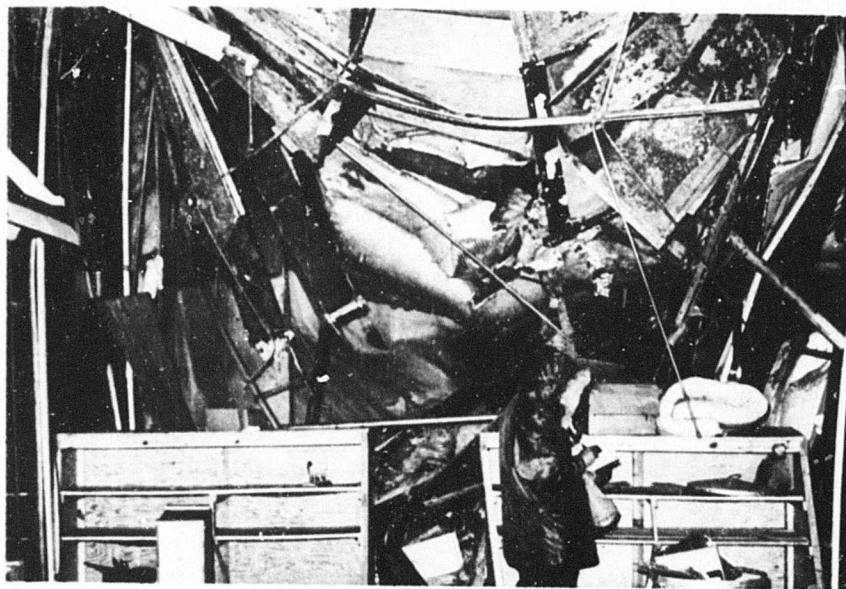
Figure 17. Metal arch pushing through roof at west end of reactor building (Trench 5).

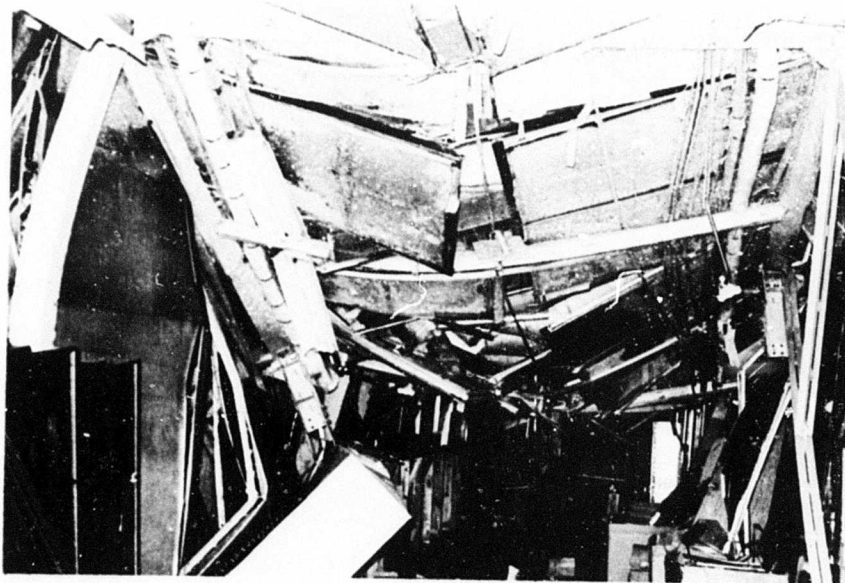
Figure 18. Deterioration of reactor building (Trench 5).

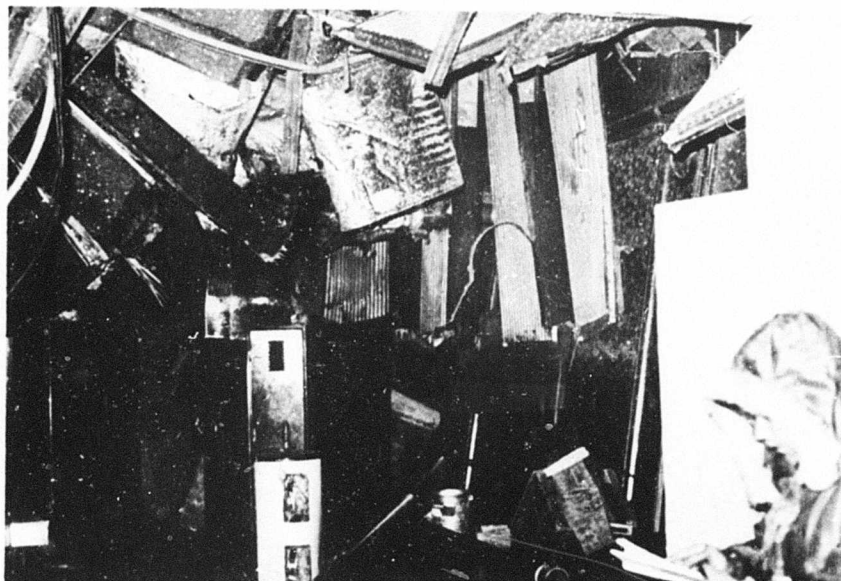
Figure 19. Deterioration of reactor building (Trench 5).

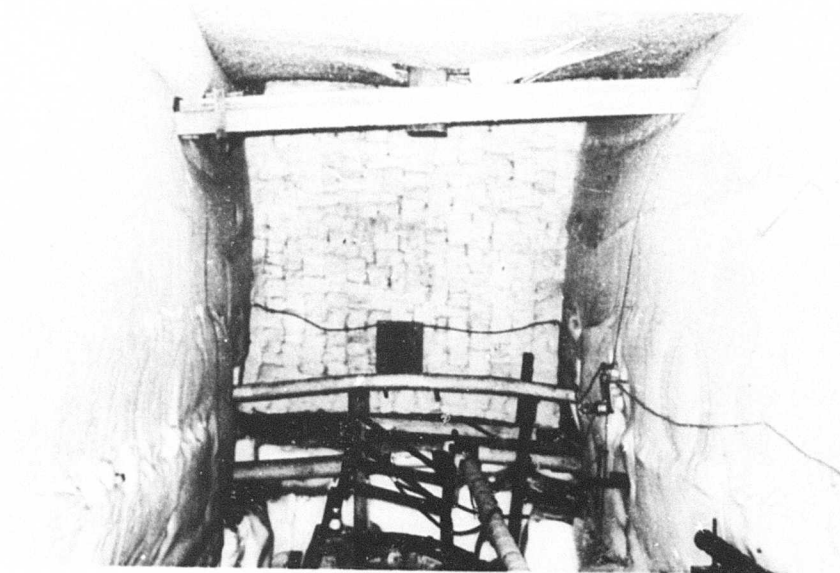
Figure 39. Snow deformation in Trench 8 causes pipeline to buckle.

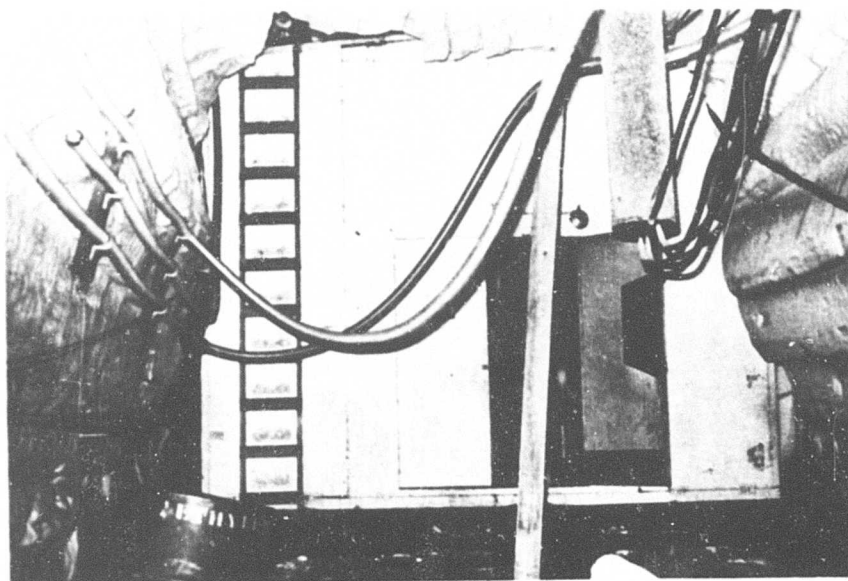
Figure 68. Snow encroaching on standby generator building.

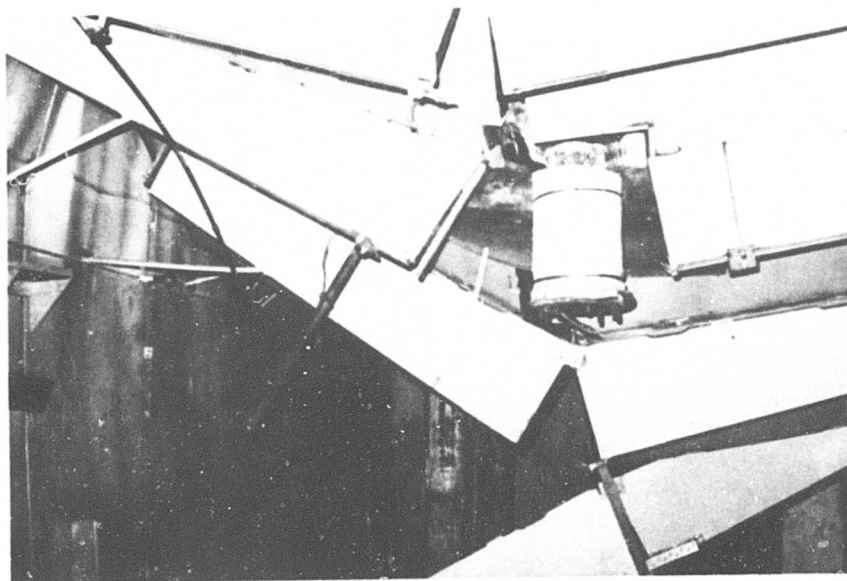
Figure 69. Effect of snow on truss ceiling Trench 15.

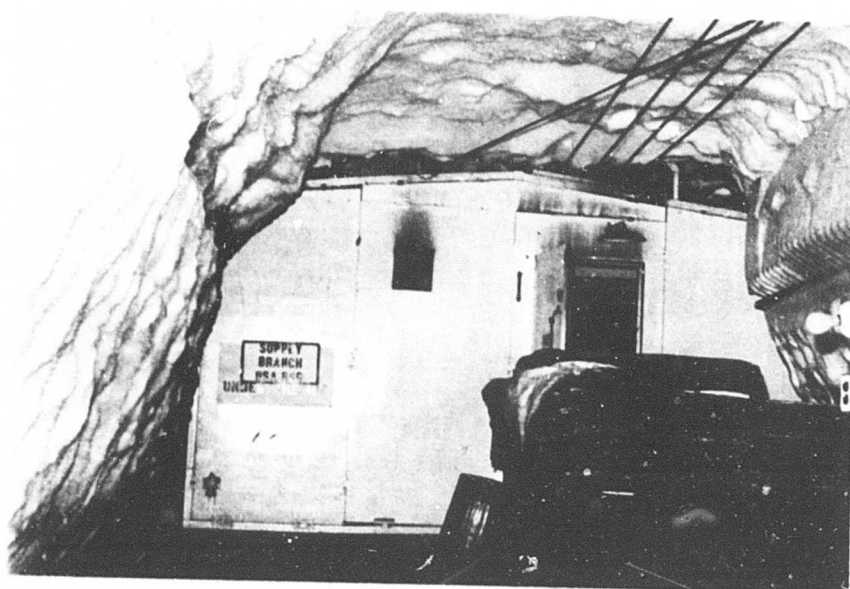
Figure 72. Snow load on roof and walls causes T-5 end wall panels to pull apart.

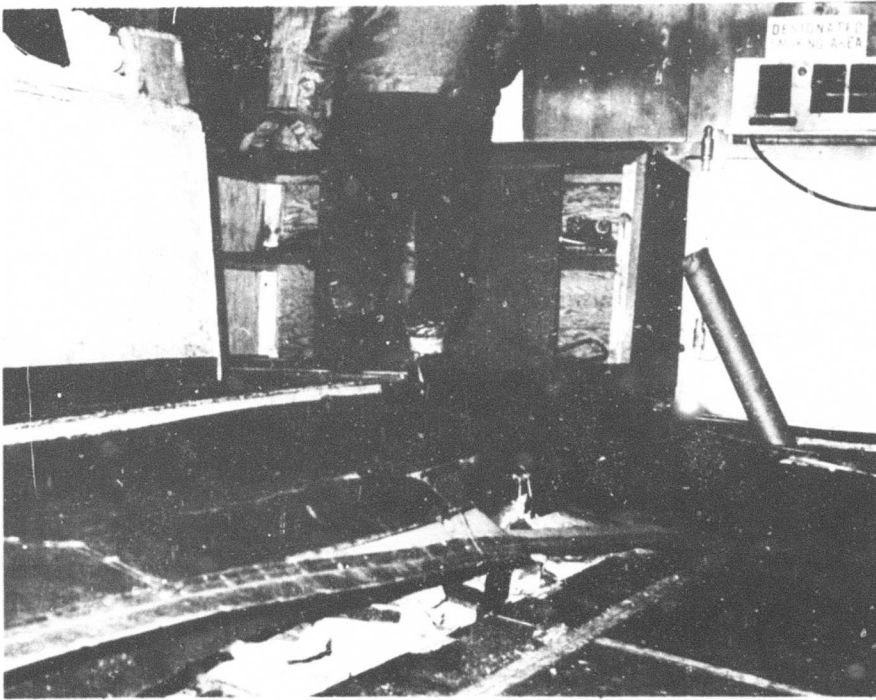
Figure 83. Tearing of maintenance shop floor as a result of trench floor arching.

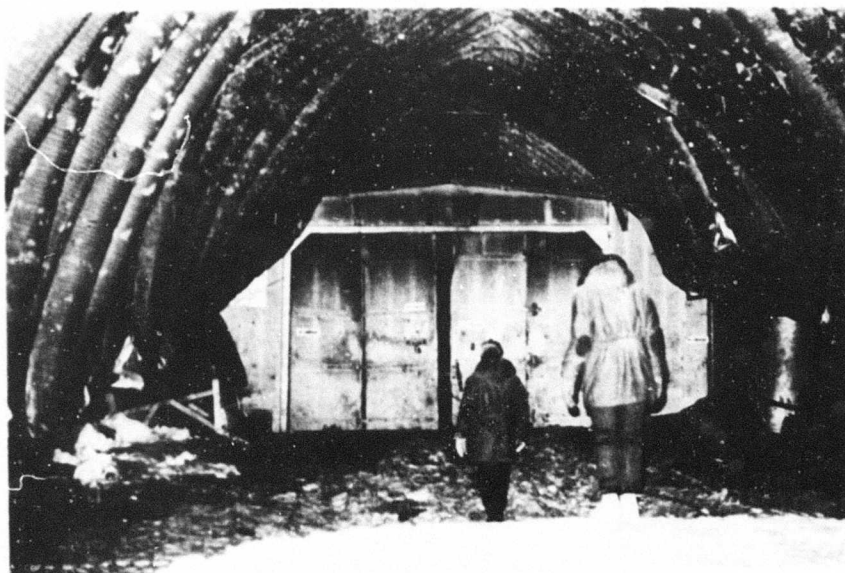
Figure 85. Steel arch deformation around maintenance shop.
